**National Highway
Traffic Safety
Administration**

Case Vehicle (A): 1999 Mercury
 Type: Mountaineer, 4-door SUV
 Driver: 56-year-old male
 CDC: 12-FZEW-2

Vehicle (B): 2000 Ford
 Type: E-350 extended passenger van
 Driver: 39-year-old female
 CDC: 06-BYEW-2

SITUATION

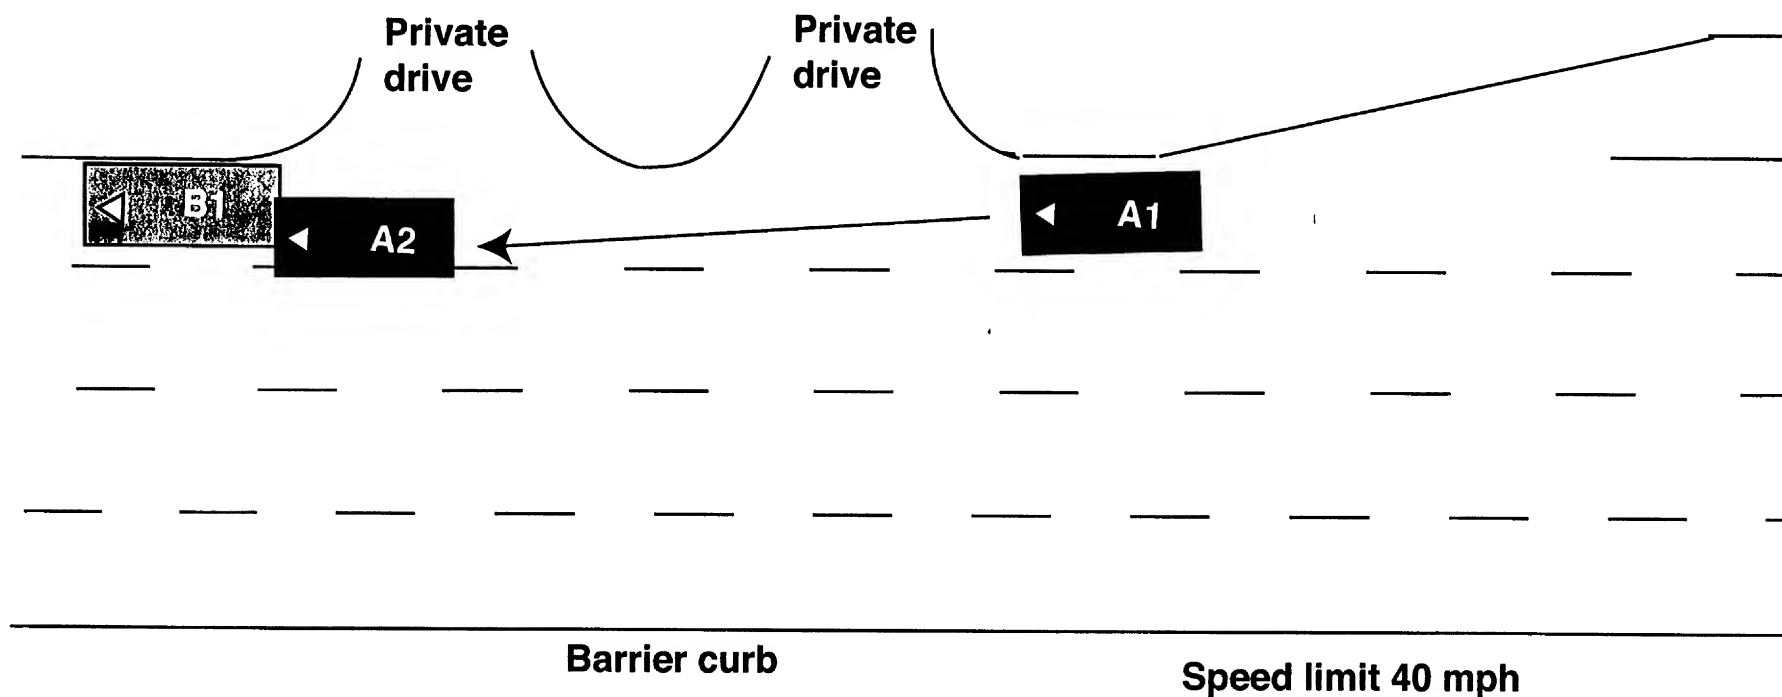
ACCIDENT SCHEMATIC

ACCIDENT DESCRIPTION: Case vehicle (A) was traveling west in the outside westbound lane of a 4-lane roadway. Vehicle (B) was traveling west in the same westbound lane, ahead of case vehicle (A). The driver of case vehicle (A) reportedly took off his seat belt to pick up an item that had fallen onto the floor from the right-front seat. When he looked up, he saw vehicle (B) stopping in traffic ahead of him. The driver of case vehicle (A) reportedly attempted to avoid a collision by veering to the left and braking. Case vehicle (A) struck the left-rear portion of vehicle (B) with its right-front end.

(Slide 1) Case vehicle (A) was traveling west in the outside westbound lane of a straight section of a dry, asphalt, four-lane roadway, (slide 2) with a speed limit of 64 kph (40 mph). Vehicle (B) was traveling west in the same westbound lane, ahead of case vehicle (A). The driver of case vehicle (A) reportedly took off his seatbelt to pick up an item that had fallen onto the floor from the right-front seat. When he looked up, he saw vehicle (B) stopping in traffic ahead of him. The driver of case vehicle (A) reportedly attempted to avoid a collision by veering to the left and braking. Case vehicle (A) struck the left rear of vehicle (B) with its right front.

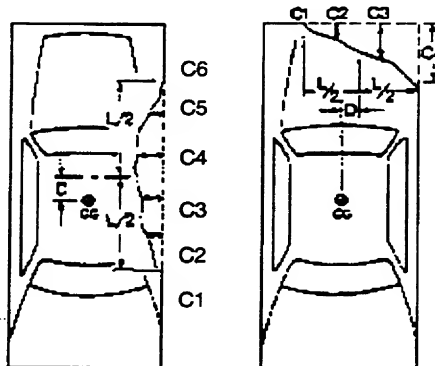
Specific Impact No.	Location of Direct Damage	Location of Field L
1	Begins (R) front bumper corner	B.C. to B.C.

DL 100

UDL 50

Specific Impact Number	Plane of Impact C-Measur.	Direct Damage		Field L	C ₁	C ₂	C ₃	C ₄	C ₅	C ₆	±D
		Length (DDL)	Max Crush								
	Bumper	100	C6	142	12	6	5	24	16	24	+21
	-Freospace				-10	-1	-0	-0	-1	-10	
						5	5	24	15	14	
	Above bumper		45		15	13	28	42	48	61	
	-Freospace				-16	-11	-10	-10	-11	-16	
	SUM				0	2	18	32	37	45	
	Averaged				N/A	N/A	23	N/A	52	59	
	Stringline adj		-3				12		26	30	
					-3	-3	-3	-3	-3	-3	
1	5	100	042	142	000	002	009	021	023	027	+021
13	14	15 16 17	18 19 20	21 22 23	24 25 26	27 28 29	30 31 32	33 34 35	36 37 38	39 40 41	42 43 44 45
2

(Slide 3) Damage to case vehicle (A) was moderate. The direct-damage length was 100 cm and began at the right-front bumper corner, resulting in a 64% vehicle overlap. The maximum crush was 42 cm and occurred at the right-front bumper corner, above the bumper. The left wheelbase was extended 6 cm, and the right wheelbase was reduced 10 cm.

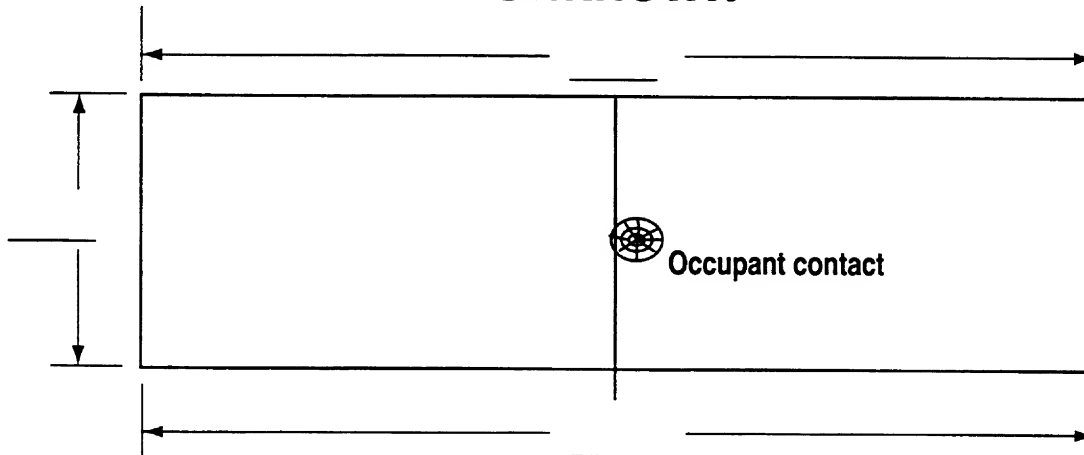
LOCATE AREA OF WINDSHIELD INTEREST OR DAMAGE WITH DIMENSIONS (VERTICAL & HORIZONTAL) ON THIS DIAGRAM OF THE WINDSHIELD AS VIEWED FROM INSIDE.

the right knee, (slides 38, 39) from axial loading through the thigh due to knee contact with the knee bolster. (Slide 40) A spider web pattern was noted near the center of the windshield, but no injury was reported that could be associated with it.

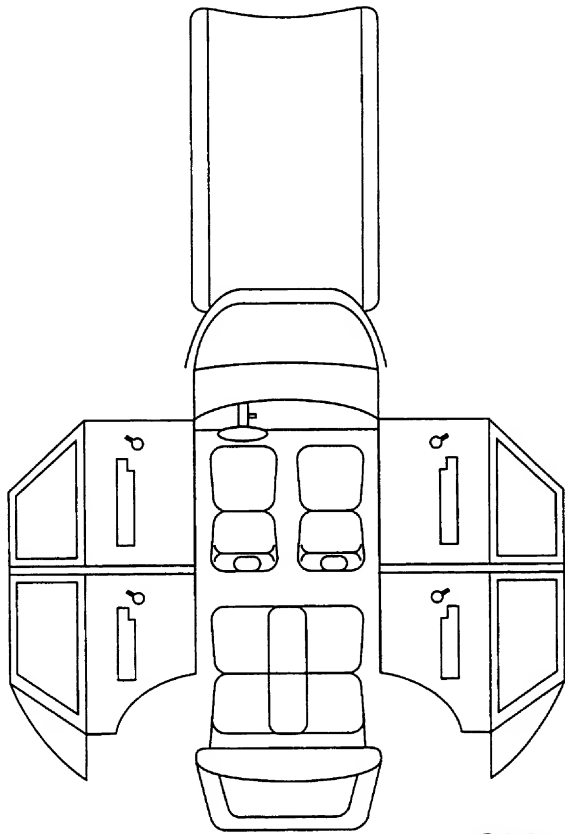
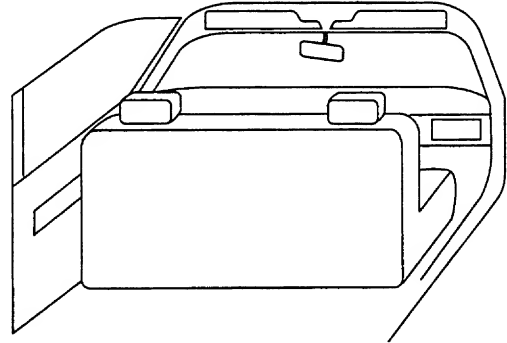
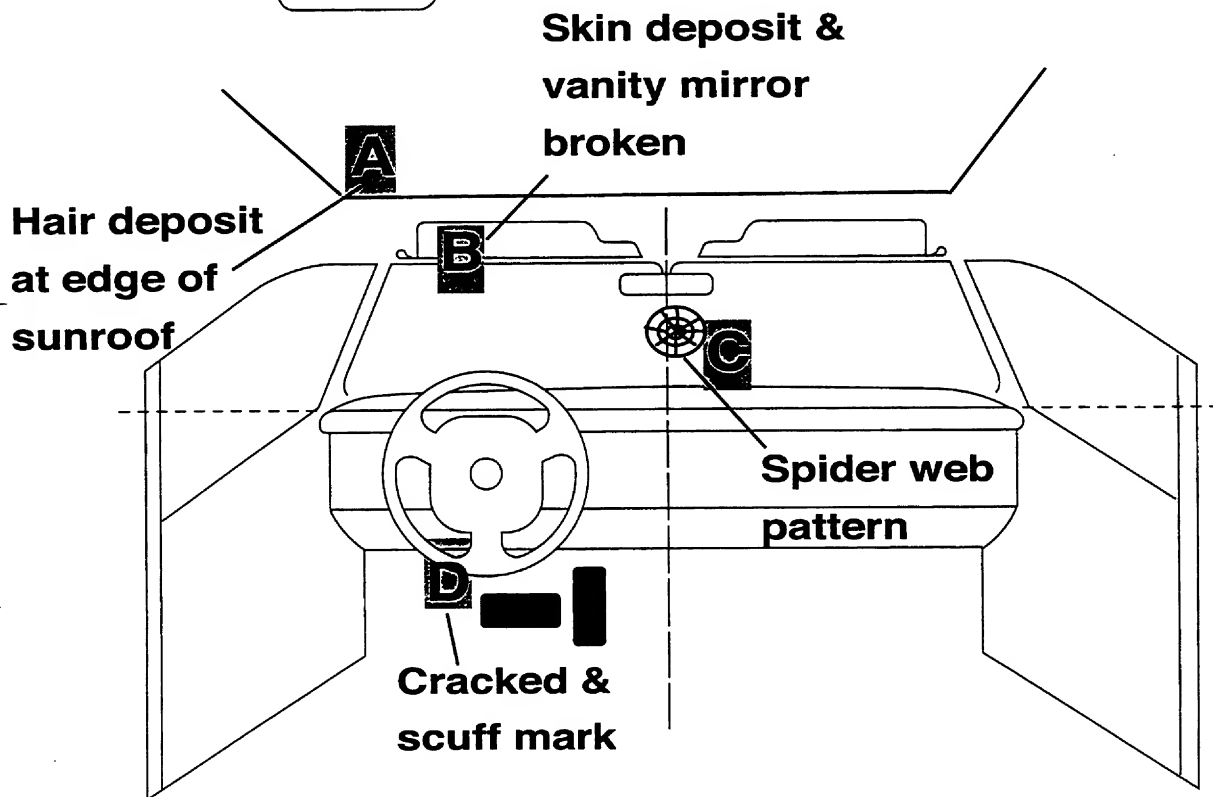
OCCUPANT CONTACT WORKSHEET

Contact	Interior Component Contacted	Occupant No. if Known	Body Region if Known	Supporting Physical Evidence	Confidence Level of Contact Point
A	Sunroof molding	1	Head	Hair deposits	1
B	Sunvisor	1	Head/face	Skin deposit & vanity mirror broken	1
C	Windshield	1	Hand	Spider web pattern	1
D	Knee bolster	1	Knee	Cracked & scuff mark	1
E					
F					
G					
H					
I					
J					
K

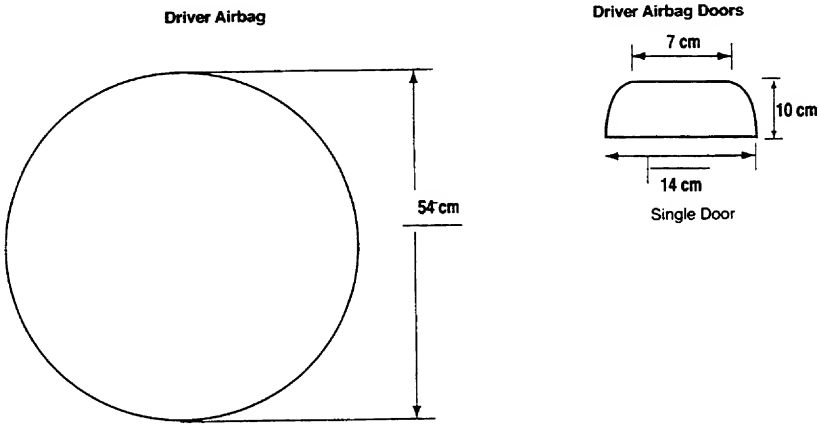
NOTE AND DESCRIBE ANY AIRBAG CONTACT OR
DAMAGE ON DIAGRAM BELOW:

Vents: ☒ N
if yes, how many: 2

Tethers: ☒ N
if yes, how many: 2

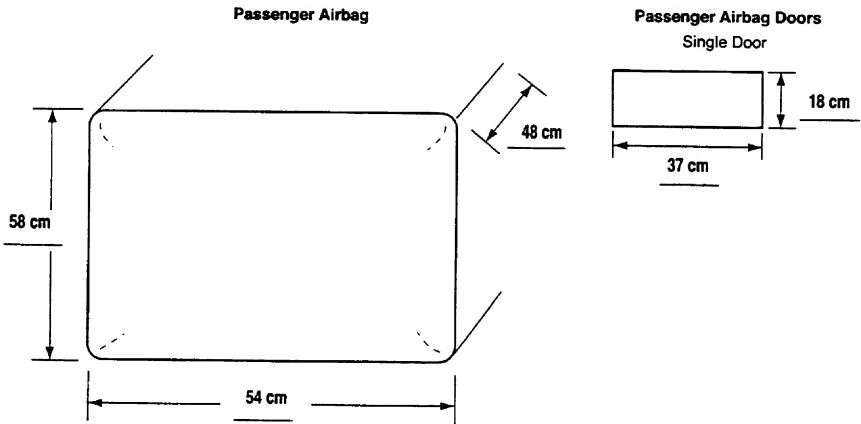
NOTE AND DESCRIBE ANY AIRBAG CONTACT OR
DAMAGE ON DIAGRAM BELOW:

Vents: ☒ N
if yes, how many: 2

Tethers: Y ☒
if yes, how many:

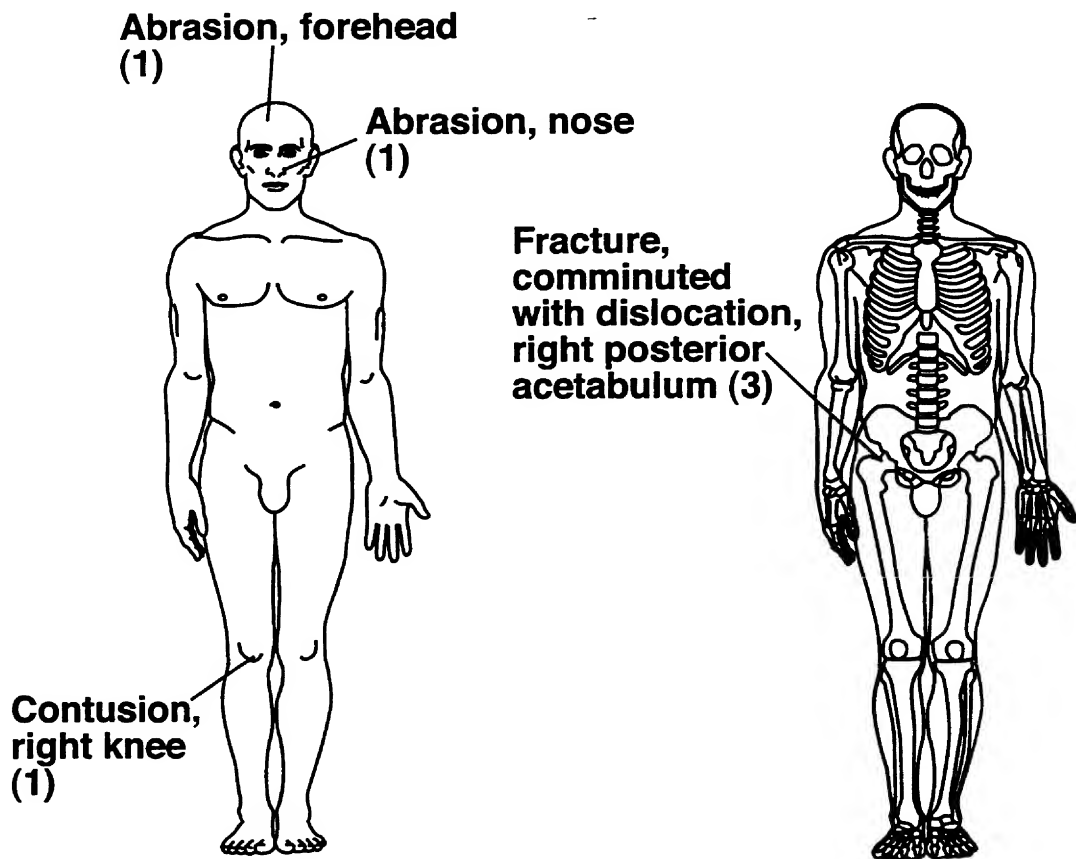
INDICATE LOCATION OF INJURIES.

The following table and (slide 41) attached drawing summarize the injuries sustained by the driver.

Injury Description	A.I.S.	Injury Source		
		Definite	Probable	Possible
Abrasion, forehead	1		Sunroof molding	Sunvisor
Abrasion, nose	1		Airbag	
Fracture, comminuted with dislocation, right posterior acetabulum	3	Knee bolster		
Contusion, right knee	1	Knee bolster		
<u>Maximum A.I.S. Level</u>	<u>3</u>			
<u>Injury Severity Score</u>	<u>10</u>
